Manhole Inspection Summary

Manhole # S31SS_048MH

Location Address: **2824 FOX ST**

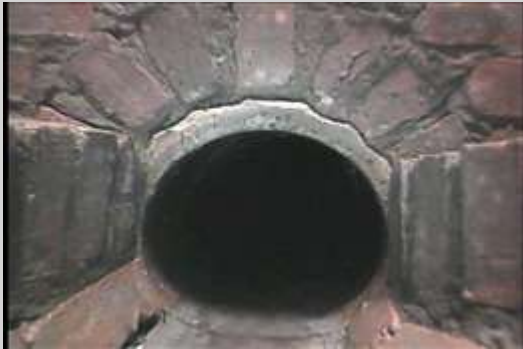
8 in. Circular Gravity Sewer Pipe Out @ 12 O'Clock

Invert Depth: **8.74** (ft.) Flow Characteristics: **Fast**

Deposits: ☒ None ☐ Mud ☐ Sludge ☐ Debris ☐ Grease

Infiltration: **None** Pipe Seal Cond: **Unknown**

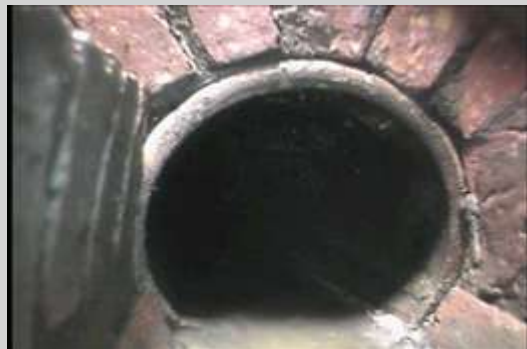
Pipe In @ 6 O'Clock

Infiltration: **None**
